## ANALYSIS OF THE CAUSES OF FAILURE OF THE SURGICAL - ORTHODONTIC TREATMENT OF IMPACTED PERMANENT UPPER CANINES - CT STUDY

ČERNOCHOVÁ P.<sup>1</sup>, KRUPA P.<sup>2</sup>

<sup>1</sup>Department of Stomatology and <sup>2</sup>Department of Radiodiagnostic Imaging, St. Anne's Teaching Hospital, Faculty of Medicine, Masaryk University, Brno

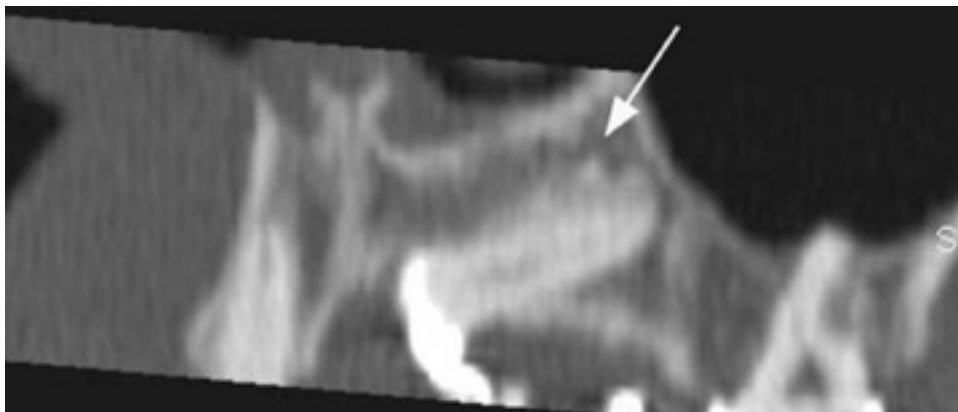
The cause of the failure was the ankylosis of the root of the impacted canine. *Fig. 1* shows the multiplanar reconstruction (MPR) in the plane going through the long axis of the impacted canine. At the surface of the canine in the cranial direction towards the nasal sinus there is a structure in the central and apical third, whose density is close to the density of the compact bone and which can be considered as ankylosis. The affected canine had to be extracted. The presence of ankylosis and its location were confirmed during surgical extraction.

*Fig. 1*  
Multiplanar reconstruction (MPR) in the plane going through the long axis of the impacted canine (arrow shows location of ankylosis)

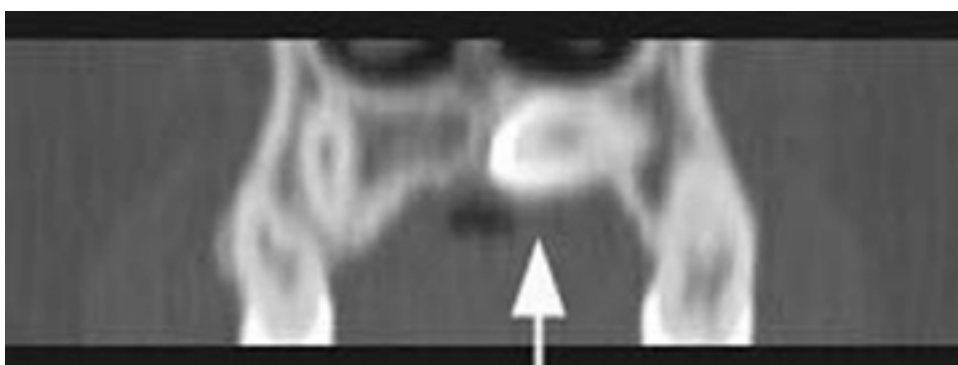
The cause of failure of the orthodontic movement of the impacted canine was its unsuitable position. It was located horizontally in the palatal process of maxilla where it was surrounded only by compact bone and no spongiosis. Therefore it did not have sufficient space to move in (*Fig. 2*). The canine was extracted. Surgical

*Fig. 2*  
Multiplanar reconstruction (MPR) in the transversal plane - the impacted canine is located horizontally in the palatal process of the maxilla (arrow)

findings excluded ankylosis and confirmed blocking of the canine in the palatal process of maxilla.

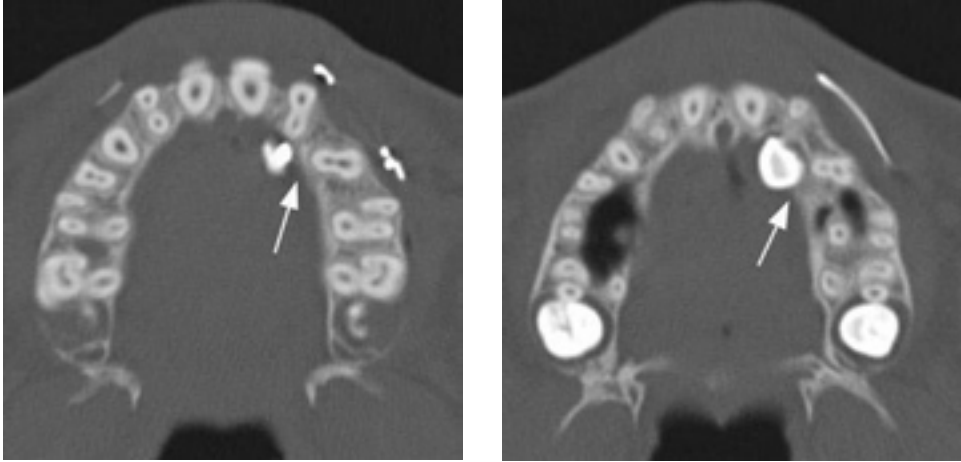
*Figs. 3a, 3b*

CT scans showed collision of the crown by the orthodontically moved canine and roots of the adjacent premolars. At *Fig. 3a* and *3b* it is obvious that during opening of the space for the left impacted transposed canine, both premolars were rotated. The first premolar rotated mesially and the second premolar distally, by which the place necessary for alignment of the canine into the arch was closed. After removal

Axial CT scans of maxilla - the crown of the impacted canine is in collision with roots of rotated premolars (arrow)

of the collision by uprighting of roots and de-rotation of the adjacent premolars, the canine was successfully moved to the arch.

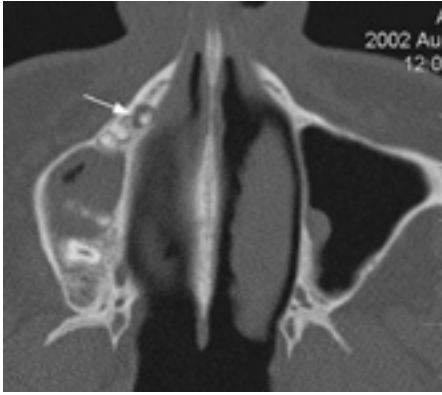
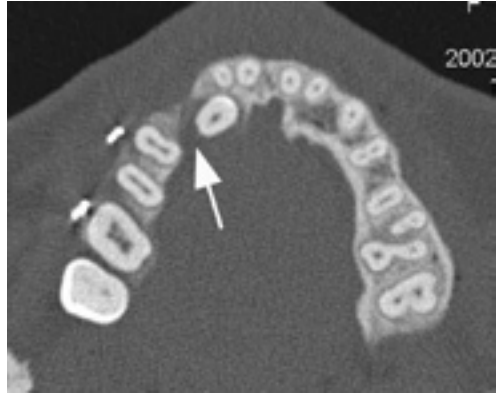
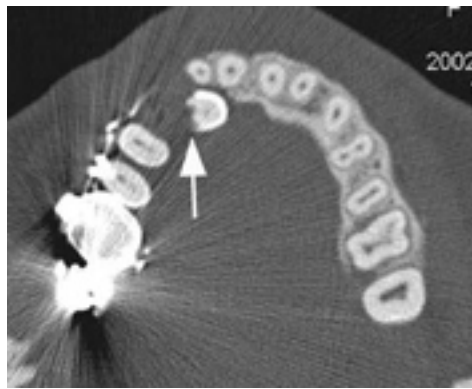
*Figs. 4a to 4c*

CT scanning revealed periapical granuloma around the root of the exposed canine communicating with the nasal sinus. Also a bone defect was found in the direction of the required movement of the canine and extensive external resorption of the canine (*Fig. 4a to 4d*). The affected canine was extracted. During extraction, presence of the periapical granuloma was confirmed as well as the granulation tissue which was filling the bone defect and obstructed the orthodontic movement of the tooth.

Axial CT scans of maxilla - periapical granuloma of the impacted canine (thin arrow), bone defect in the surroundings and external resorption of the impacted canine (thick arrow)

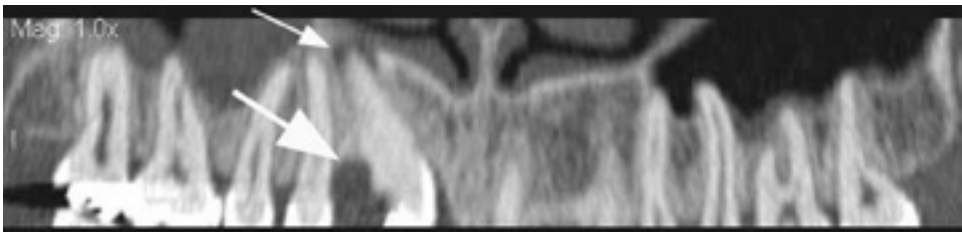
*Fig. 4d*

Multiplanar reconstruction (MPR) - right impacted canine with periapical granuloma communicating with the nasal sinus (thin arrow), and with the bone defect and resorption of enamel and dentin of the cervical part of the canine (thick arrow)

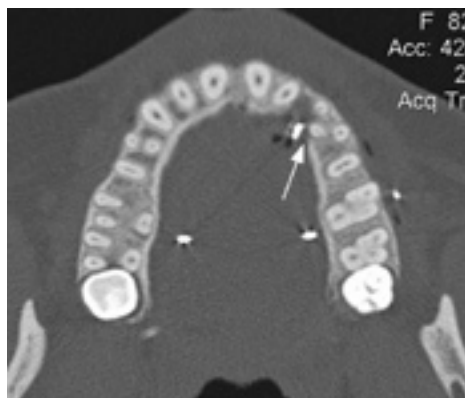
*Fig. 5a*

At *Fig. 5a to 5c* it is apparent that the crown of the impacted canine is in collision with a shortened palatal root of the first premolar. The cause of failure was the unsuitable palatal access for exposure of the crown and unsuitable direction of the orthodontic force moving the canine (disto-occlusal direction of the force towards the palatal arch). We recommended the following change in the treatment - interruption of moving the canine to the palatal arch, placement fixed orthodontic appliance to the upper dental arch, opening space for the impacted canine together with de-rotation of the first premolar, extraction of the temporary canine, vestibular exposure

Axial CT scans of maxilla - the crown of the impacted canine is in collision with the palatal root of the first premolar (arrow)

of the crown of the impacted canine, occlusal orthodontic force to the canine. After making the changes, movement of the canine was successfully completed.

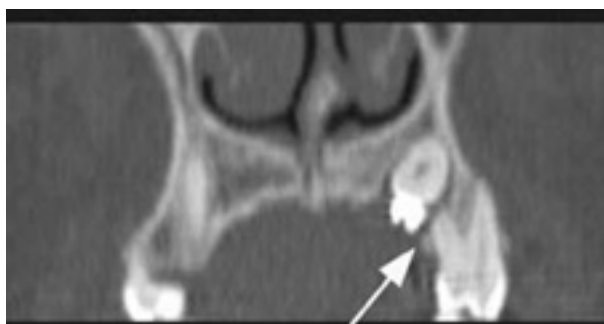
*Fig. 5b*

Multiplanar reconstruction (MPR) in the transversal plane - the crown of the impacted canine is in collision with the shortened palatal root of the first premolar (arrow)

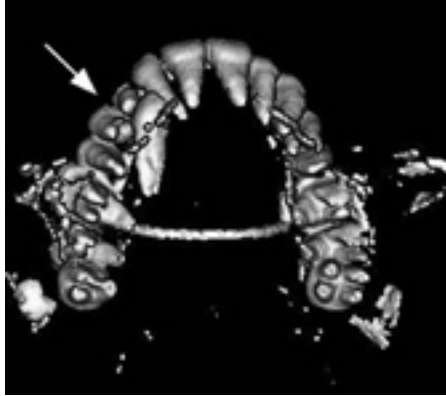
*Fig. 5c*

3D reconstruction (shaded surface display) - craniocaudal view (arrow shows the relationship between the impacted canine, temporary canine, and first premolar)

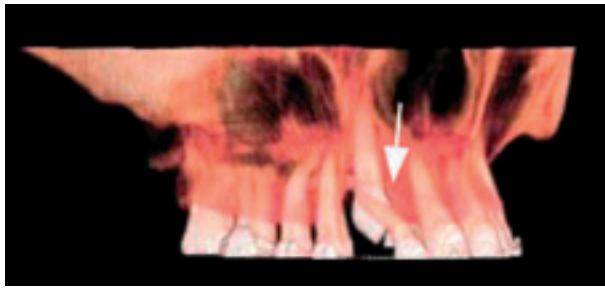
*Fig. 6a*

CT scanning showed malformation of the root of the lateral incisor which was the obstacle in the movement of the canine (*Fig. 6a* and *6b*). Extraction of the lateral incisor enabled moving the canine to the arch.

3D reconstruction (volume rendering) - lateral view

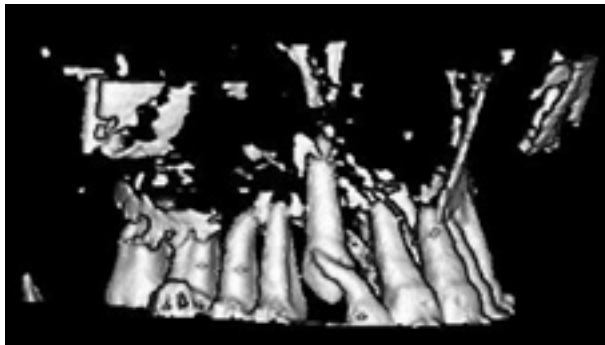
*Fig. 6b*

3D reconstruction (shaded surface display) - lateral view - the crown of the impacted canine is in collision with the deviated root of the lateral incisor (arrow)

that could be influenced an adequate change in further treatment. In three patients the cause was collision of the crown of the impacted canine with roots of the adjacent teeth, or insufficient space for orthodontic movement of the canine. In one case, unsuitable procedure of the surgical exposure was applied as well as unsuitable direction of the orthodontic force moving the canine which was caused by insufficient diagnostics of the position of the impacted canine. Malformation of roots of teeth surrounding the impacted canine can cause problems in its orthodontic movement. In literature (8), deviations of the palatal root of the first premolar are described. In one patient from our group there was deviation of the root of a lateral incisor. In order to complete orthodontic repositioning of the impacted canine, the affected lateral incisor had to be extracted regarding the extent of deviation.
